Trials and Tribulations of a Historic Pair of Covered Bridges

By Robert Parks

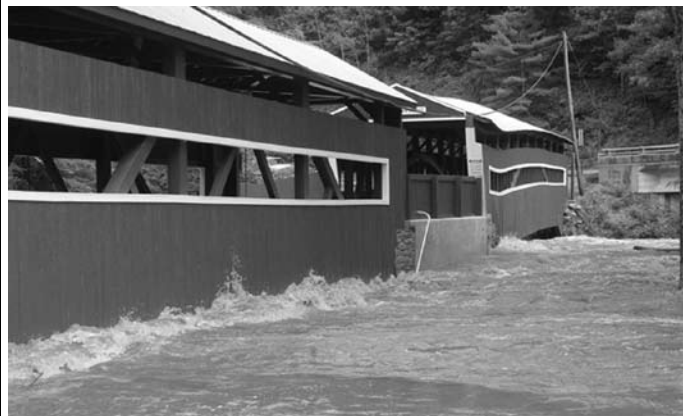
One month later on June 28, 2006, a "No Name Storm" hit the area, flooded Huntington Creek, and reaching flood stage, lifted the West Paden off her abutments and washed her downstream.

Having applied for and received a FEMA grant, the county asked for bids to rebuild an exact replica of the West Paden. Only one contractor agreed to rebuild it for that amount. They would donate their own time and equipment to complete the

bridge (A true lover of covered bridges). It was determined that the recovered older material was not usable.

Reconstruction began about mid-June 2008. First on the list was the reconstruction of the stone abutments. Since the cost of collecting and laying stone was prohibitive, the contractors used concrete forms/molds which made them appear in the shape of stones. While this was being done a crew cleared a level spot to build the trusses on the ground and when completed, would use a 20 ton crane to put them in place.

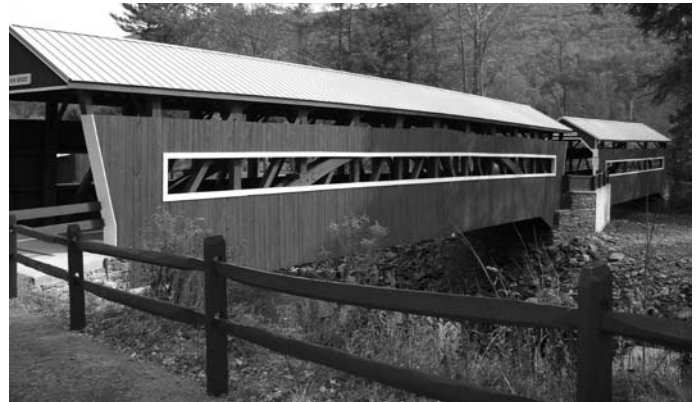
On Sept. 11, 2008, it was time to place the trusses. A small crowd gathered to watch this critical step. Would they fall into place? As they were slowly lowered, they did! Within an inch! Within the next 35 days the bridge would receive its many floor beams, lateral bracing, floor joists, finished deck, roofing and siding. Painting and backfilling followed along with protective fencing leading to the bridge.

The wooden trusses and various beams came from Oregon as the sizes of the needed arch trusses weren't available locally. These were then cut to specifications by very talented craftsmen using modern hand tools. Every cut and hole was measured and remeasured. As the trusses were completed they were primed and received a first coat of paint.
